ANALYSIS OF THE NEEDS OF TYPE A TERMINAL INFRASTRUCTURE FACILITIES IN ARJOSARI, MALANG BASED ON DISASTER MITIGATION

Tri Wahyusetianingsih¹, Harris Muhammadun², Wateno Oetomo³
Magister Teknik Sipil, FT Untag Surabaya, Indonesia
Email: ft@untag-sby.ac.id

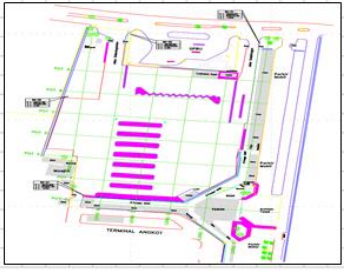
Figure 9
Filling Arjosari Terminal RVS formular
 Source: Researcher's processed data, 2023

Because the final value ($S \leq 2$), the evaluated building has a high risk due to earthquakes so a more detailed evaluation is needed.

Irregularities: Vertical (type/severity) Split Levels
 Plan (type) Reentrant Corner

COMMENTS:
 Pada bangunan Terminal Arjosari perlu dilakukan Evaluasi lebih lanjut, karena nilai akhir (Final score) ≤ 2, yaitu 0,6

FINAL LEVEL 1 SCORE, S₁ ≥ S_{min} S₁ = 1.4 + (-0.5) + (-0.6) + 0.3 = 0.6 > S_{min}

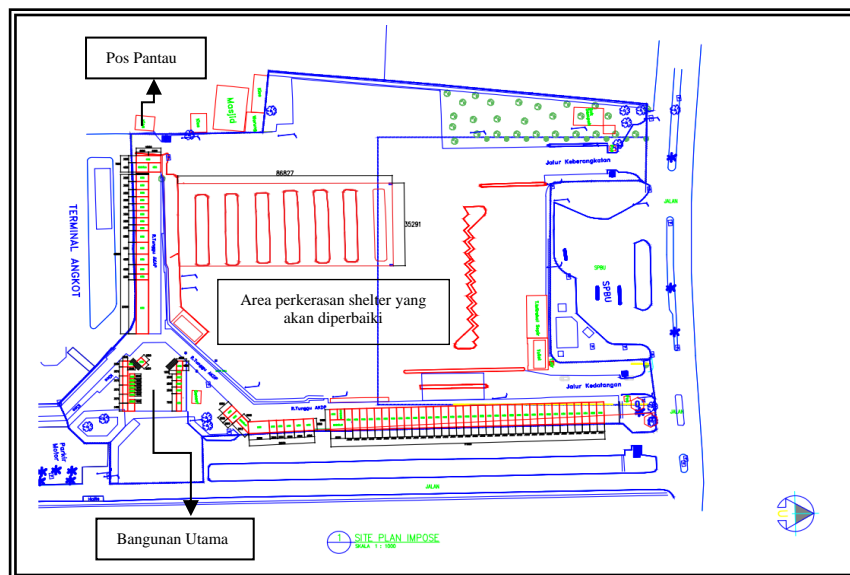
Figure 4
Floor Plan of Arjosari Terminal Malang
 Source: Researcher's processed data, 2023

No	Structural Mitigation Plan	Information
1	Repair of the roof of the terminal building	1) Many parts of the roof of the terminal building have been damaged, porous and perforated, so repairs are needed.

Based on the floor plan drawing, it can be calculated the maintenance needs of the Arjosari terminal based on disaster mitigation.

2. Repair of the roof of the main building and monitoring post

Repairs are needed on the roof of the main building and monitoring post with detailed calculation of area area as follows:
