PEDESTRIAN FACILITY DESIGN FOR SPORTS CENTRE AREA IN SMALL TOWN OF INDONESIA (CASE STUDY: BIMA SPORTS CENTRE AREA)

Mochmad ibnu safii¹, Subhan Hilmi NP², Mira Lestira Hariani³, Arni Muslimah Hardayani⁴

Universitas Swadaya Gunung Jati, Cirebon, Indonesia

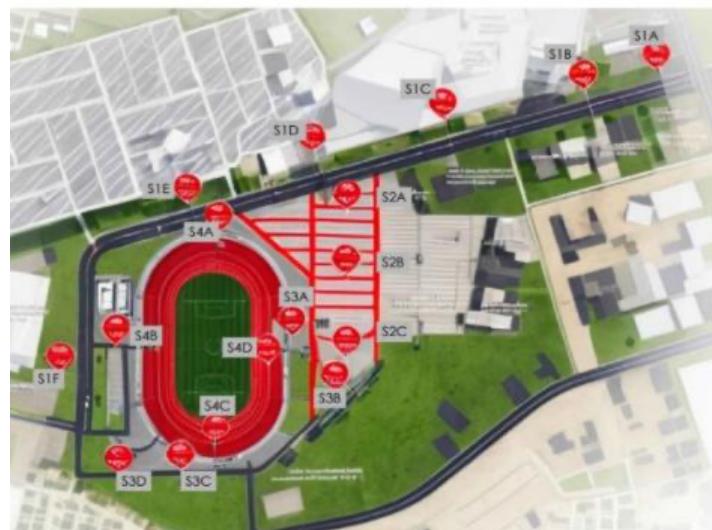
Figure 1. Research Location Delineation Maps

The research site is in the Bima sports area of Cirebon City, Indonesia. The research location point is divided into 4 (four) segments and six path types, with 17 pieces divided into the research area. The kinds of pedestrian paths at the study location are as follows:

1. Type 1 : (Separated) Sidewalk is found in segment 1A-1F and segment 2A-2C
2. Type 2 : (Separated) Boulevard is on segment 1
3. Type 3 : (Car Dominant) Pedestrian ways use public roads, but vehicles are more dominant as in segments 3A, 3B
4. Type 4 : (Integration) Pedestrian ways using public roads are found in segment 3C, 3D
5. Type 5 : (Path) types used by pedestrians, bicycles, runners and joggers. It is not intended for pedestrians only in segments 4A-4D.

6. Type 6 : (Corridor) Covers corridors, connecting roads between pedestrian paths. Vehicles are prohibited from passing through this lane, as found in segment 3.

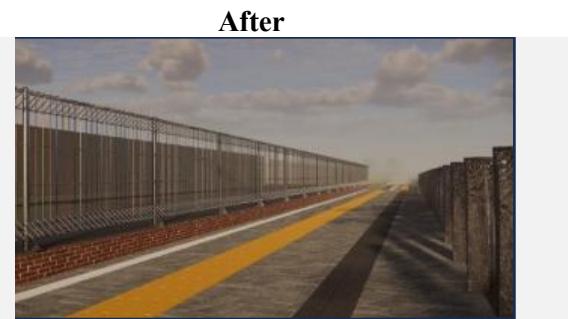
Figure 12. 1 D Segment Design Prototype

The research results obtained in segment 1D have a good PLOS value, namely B. Still, several elements need to be improved on the disability path and safety fences, as shown in Figure 12.

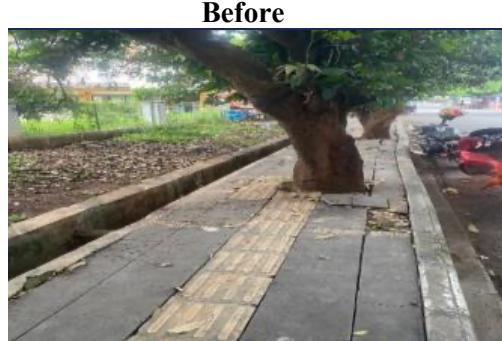
Figure 13. Existing Condition Segment 2 B

The research results obtained in segment 2B have a problem with the pedestrian path where the vegetation area is combined with the pedestrian path, as shown in Figure 13. This results in the low PLOS value in this segment, namely C. Therefore, as shown in Figure 14, this study recommends a redesign by separating the pedestrian and vegetation paths, increasing the PLOS value in this segment.

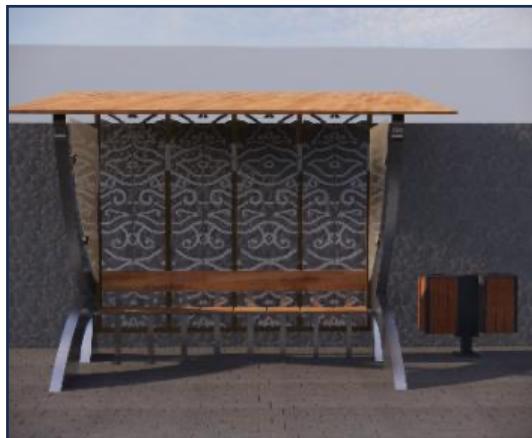
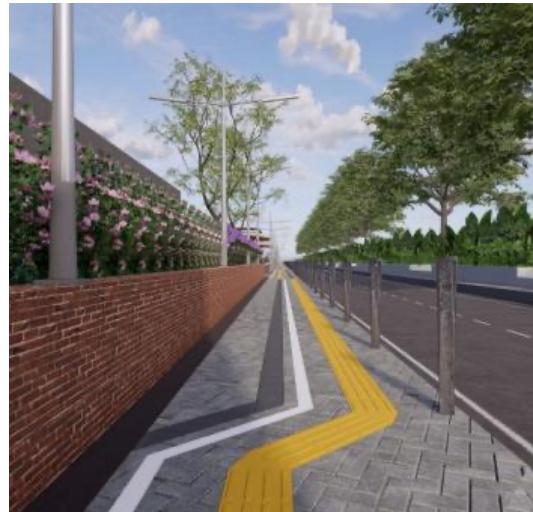
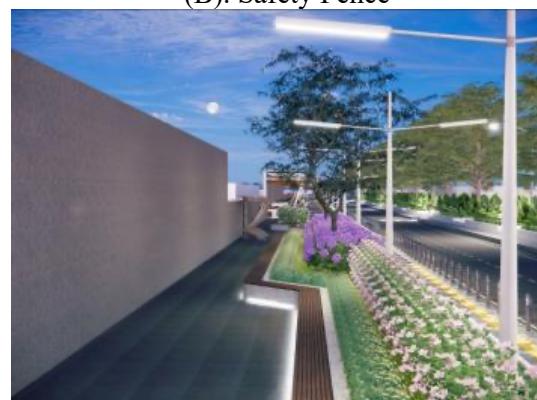
Figure 17 shows the recommendations for facilities emphasized in the design based on pedestrian perceptions of the importance of cleanliness, security, and lighting.

(A). Shelters and trash cans

(B). Safety Fence

(C). Seating

(D). Lighting Lamp

Figure 17. Facilities emphasized in the design based on Pedestrian perception

Based on the results of the CSI analysis, the design recommendations emphasize the Provision of cleaning, security, and lighting facilities. In addition, in locations with less than the standard width, it is recommended that facilities be widened and provided according to PU standard No.03/PRT/M/2014.
